Subject: Brunswick Steam Electric Plant, Unit No. 1
Docket No. 50-325/License No. DPR-71
Licensee Event Report 1-2004-002

LICENSEE EVENT REPORT (LER)

4. TITLE
Manual Reactor Shutdown During Loss of Offsite Power Event

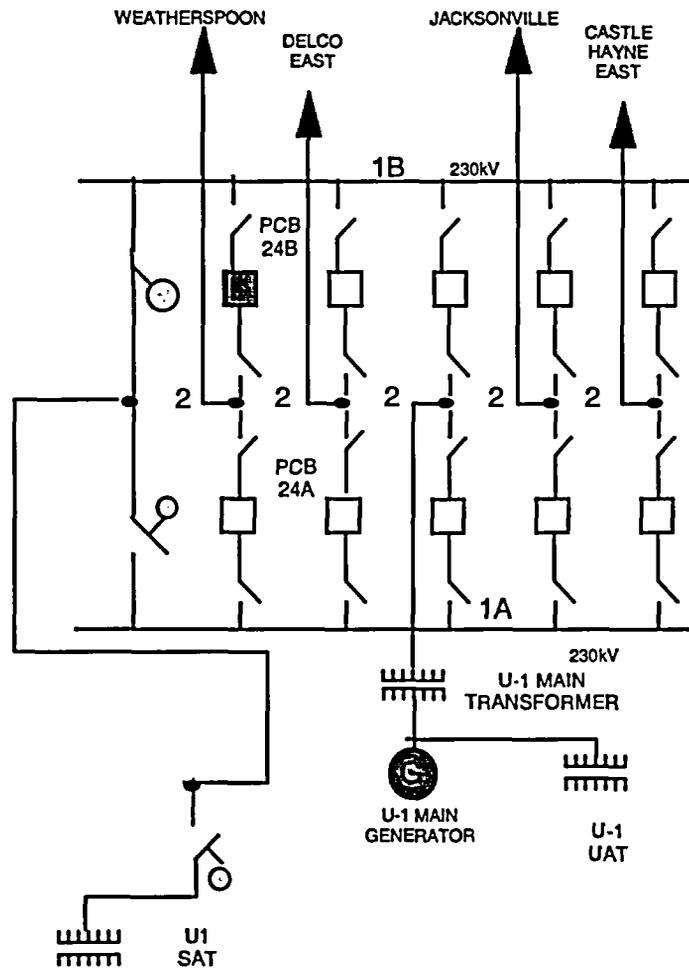
Unit 1 Switchyard Arrangement

Upon sensing the faulted condition created by the insulator failure, PCBs 24A and 24B opened. PCB 24B, being the preferred breaker, reclosed and tripped after 15 seconds and again after 50 seconds since the fault was still present. PCB 24A did not attempt to reclose since it requires PCB 24B to remain closed for a period of time before it will attempt to close. Even though PCB 24B cycled open as designed, instrumentation indicates that fault current was still present through the breaker contacts after the third trip. At this point the 230 kV 1B bus B phase differential relay operated resulting in a primary lockout of the 1B bus.

Breaker testing and vendor component failure analysis concluded that PCB 24B failed due to an internal bushing failure, which resulted in current flashover within the breaker. The bushing failure is attributed to moisture intrusion. The fault condition in combination with moisture produced an arc which was sensed by the bus differential relay and ultimately resulted in a primary lockout of the 1B bus. The root cause of this event is attributed to an inadequate PCB maintenance process. Specifically, preventive and corrective maintenance being applied to the breakers has not identified the adverse trend of moisture build up in the bushings as a problem that requires corrective action.

The non-preferred breaker will not attempt to close unless the preferred breaker successfully closes and remains closed for a predetermined time. Historically, the preferred scheme has been configured with two of the breakers aligned to the 1A bus and two breakers aligned to the 1B bus. This breaker scheme was originally established based on the assumption that a breaker failure bus trip would not strip both 230kV buses on the unit and cause a load reject from the turbine. However, based on the circumstances of this event, had the preferred breaker scheme been arranged such that the SAT was connected to the non-preferred bus and the PCB 24B failed in the same manner, the event would have been limited to a bus strip without a loss of the SAT.

- PCB 24B degraded bushing has been replaced and the breaker restored to service.
- Leak checks of site PCBs will be performed and a plan developed to correct identified deficiencies based on leak detection results by December 15, 2004.
- Preventive and corrective maintenance processes will be revised as needed to establish adequate measures for identifying and trending moisture intrusion into PCBs and ensure needed corrective actions to resolve identified moisture intrusion related deficiencies are identified within the corrective action program for timely resolution.
- The breaker scheme on both units has been aligned such that the SAT is connected to the non-preferred bus.
- Applicable plant procedures will be revised to reflect the preferred breaker scheme for SAT alignment.
